4.3 ANALYSIS AND RECOMMENDATIONS - MID & WEST SIDE

4.3.1 MWR (WEST) - AREA #3W

BLDGs. 1900-1910 - OFFICER'S CLUB COMPLEX BLDG. 1911 - FLIGHT CREW QUARTERS

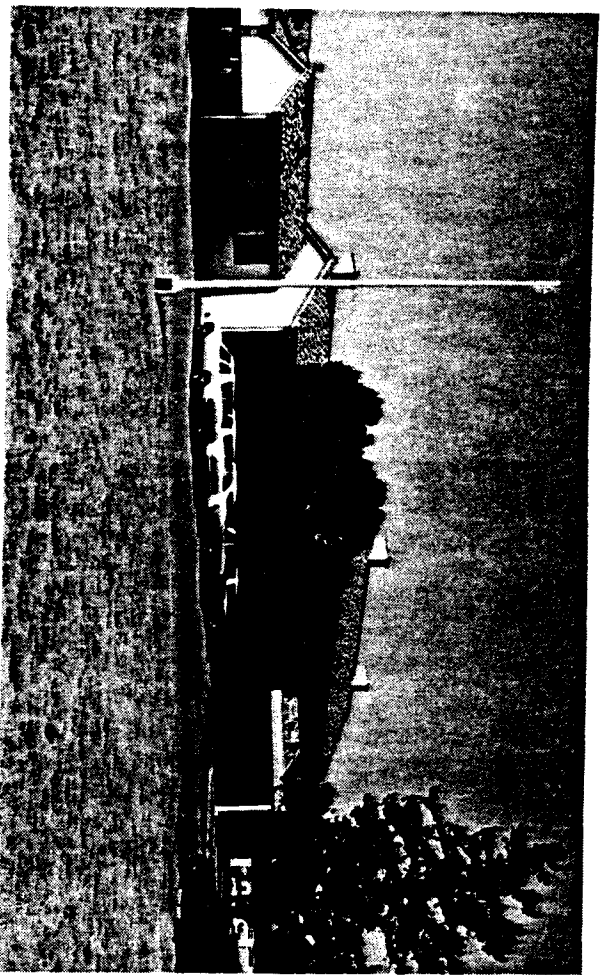
View of Bldg. 1900 entrance looking north

CONCERNS (Bldg. 1900 - Officers' Club complex)

- The buildings need maintenance.
- Some buildings have incompatible improvements.
- The fencing is not compatible with architecture.

RECOMMENDATIONS

- Repair and maintain roofs, walls and windows in accordance with standards set by the Department of the Interior for Historic Buildings.
- Demolish Bldg. 1903 & 1910.
- Replace fence with stucco and tile to match the building.

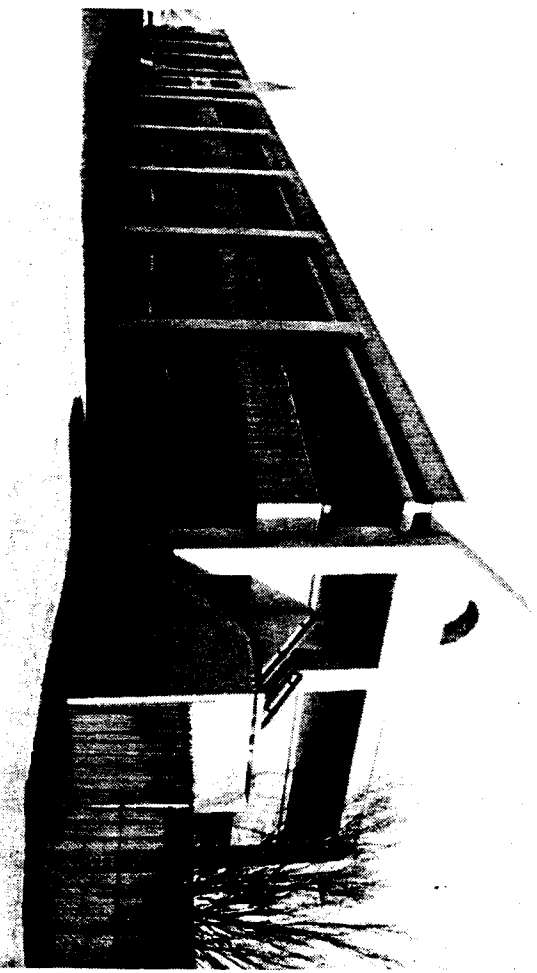
CONCERNS (Bldg. 1911)

- The contemporary design of this building is not compatible with the Officers' Club.
- Colors of this building are not compatible with the area.

- Fencing is unattractive.
- Vehicular access is limited.

Bldg. 1911, illustrating non-compatibility with Bldg. 1900

RECOMMENDATIONS (Bldg. 1911)

- Visually separate building from the Officers' Club with dense landscaping, trees and its own driveway.
- Change color to match the Officers' Club.
- Replace fencing with stucco wall.
- Provide independent drive from Maxwell Avenue.

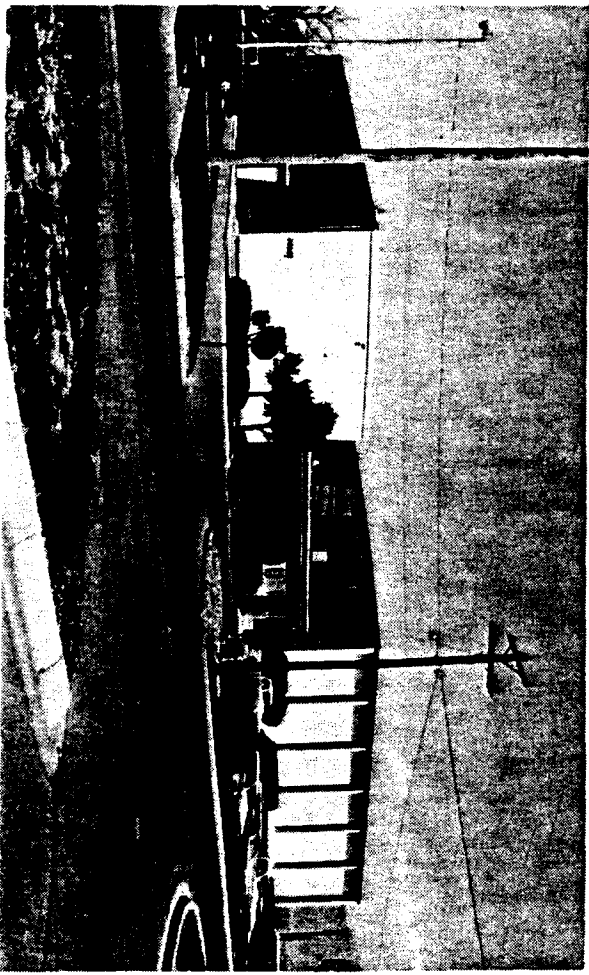
Bldg. 585 - Gymnasium

CONCERNS

- *Mechanical equipment locted on roof above entrance lobby is very unattractive.*
- *Wall surface treatment and fascia designs lack unity.*
- *Building has a flat roof.*
- *Perimeter of recreation site lacks trees and landscape development to promote a recreational image.*
- *Parking along Aberdeen Drive is not screened from view.*

RECOMMENDATIONS

- *Construct a raised parapet around the perimeter to unify facade and provide architectural interest.*
- *Screen mechanical equipment with parapet.*
- *Provide low slope roof behind parapet.*
- *Provide landscape perimeter and beams to screen parking and promote recreation environment.*

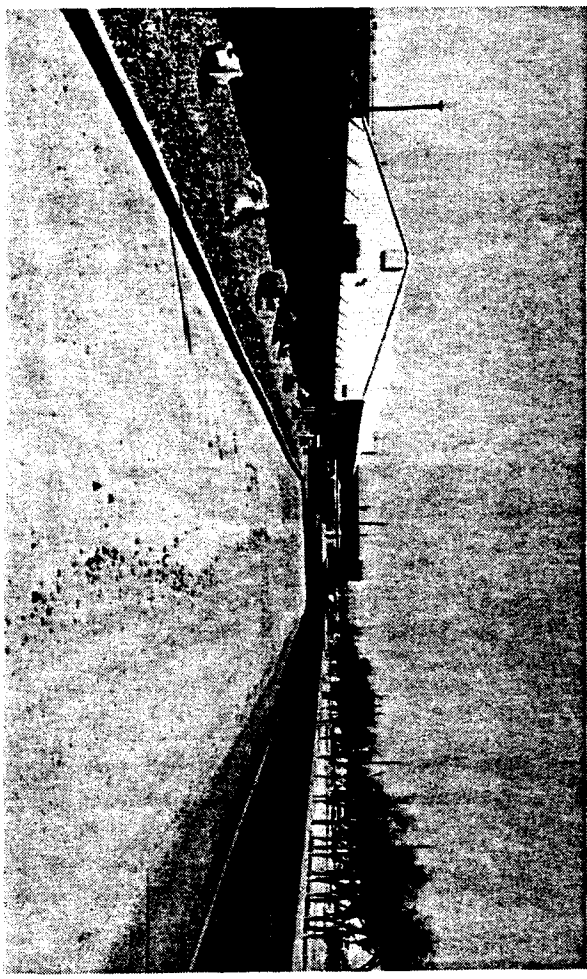
View of Kirtland Road looking west

CONCERNS

- *Bldg. 1025 is not compatible with Bldg. 1032.*
- *Chain link fence is unattractive and does not effectively screen clutter.*
- *The land between the fence and Kirtland Road lacks a landscaped buffer.*
- *Right angle parking off Kirtland Road presents a potential hazard.*
- *Site use is visually incompatible with adjacent flight line use and restricts potential expansion of flight operations.*

RECOMMENDATIONS

- *Remove chain link fence and install a solid screen wall using split rib CMU screen wall, color to match Bldg. 1032.*
- *Re clad the north side of Bldg. 1025 with a split-rib CMU. Paint the other three sides brown and paint the blue accent bands to match Bldg. 1032.*
- *Landscape between fence and Kirtland Road with a curvilinear design to introduce rhythm.*
- *Relocate this area to allow for future expansion of flight operations.*
- *Eliminate 90 degree parking from Kirtland Road and construct a parking lot.*

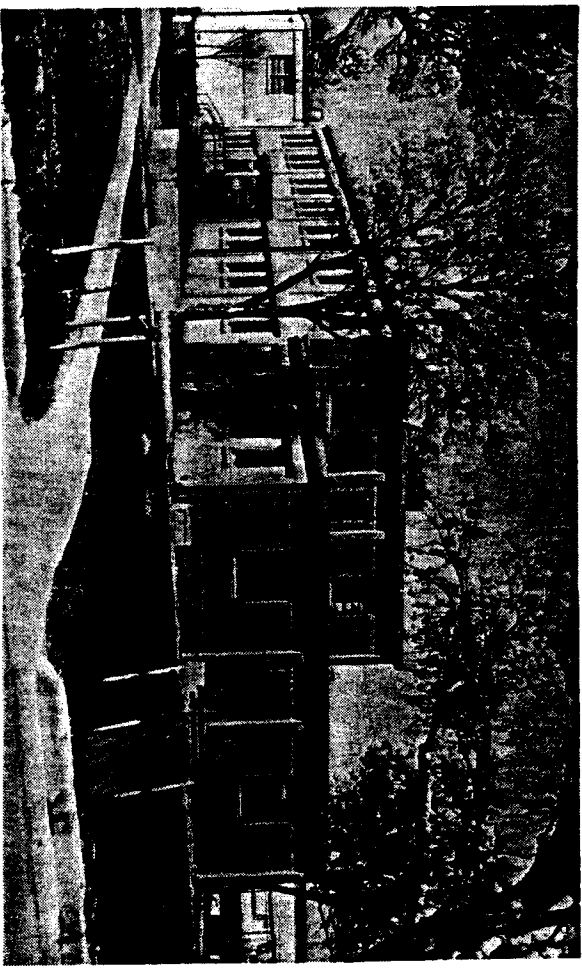
Bldg. 1019 viewed looking west

CONCERNS

- *Buildings are remotely located and lack architectural identity to the central campus complex.*
- *Buildings have flat roofs with unattractive rooftop mechanical equipment.*
- *Grade-mounted equipment along Hercules Way creates visual clutter.*
- *Signage is not unified and not in compliance with Air Force standards.*

RECOMMENDATIONS

- *Remodel buildings to unify with architectural campus theme as shown in sketch.*
- *Locate mechanical equipment on grade and screen with stucco screen walls to conceal from view.*
- *Remove signage and replace with one entrance sign and individual signs per building.*

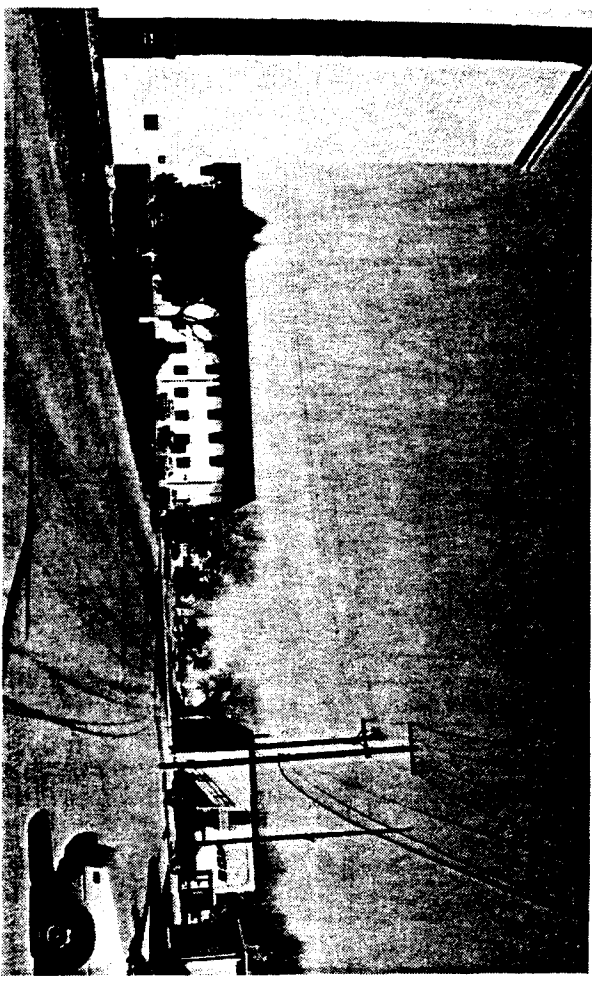
Frances Avenue viewed north from Intersection of Hercules Way

Frances Avenue serves as the main access to the southern area of the campus that houses the 542nd Squadron Operations complex. As shown in the photo at right, Frances Avenue has an undeveloped image and lacks the features necessary to link the two campus elements.

CONCERNS

- *Sidewalks are lacking to join campus areas for pedestrian movement.*
- *Elements of unity such as landscaping and street and pedestrian lighting are lacking.*
- *Several small buildings and water storage tank on east side of the road are unattractive.*
- *Parking on the east side of the street interferes with pedestrian walks.*

RECOMMENDATIONS

- *Improve street and walkways with unified design to match the campus; i.e., landscaping, paving, lighting and signage.*
- *Remove parking on east side and install walkway.*

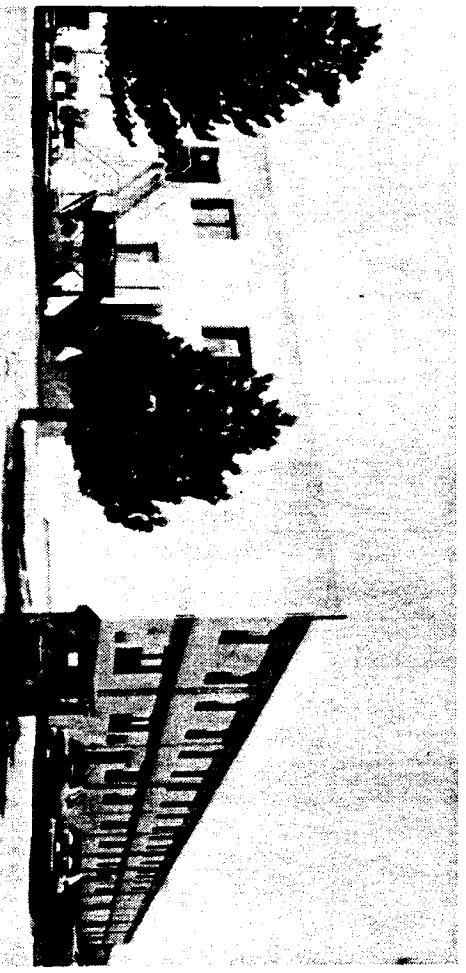
Northeast corner of Bldg. 1010, looking west

CONCERNS

- The building's imposing size, industrial image and limited setback from Randolph Avenue overpowers the smaller, human scaled building of the campus.
- Building materials and lack of style is incompatible with campus image.
- The expanse of asphalt paving from the building face to street edge promotes an industrial image.
- Exposed metal stairs also promotes an industrial appearance.
- Pedestrian entrances lack definition.

RECOMMENDATIONS

- Break up facade into smaller grouped elements to create human scale and reduce apparent length.
- Install bronze standing seam metal roof (partial shed roof) compatible with Bldg. 975.
- Add horizontal spandrels with raked finish to match dorms.
- Enclose metal stairs and screen dumpster.
- Reduce asphalt paving by adding foundation planting strip and curb line tree planting island. Also provide landscaped islands every 8 to 10 parking stalls.

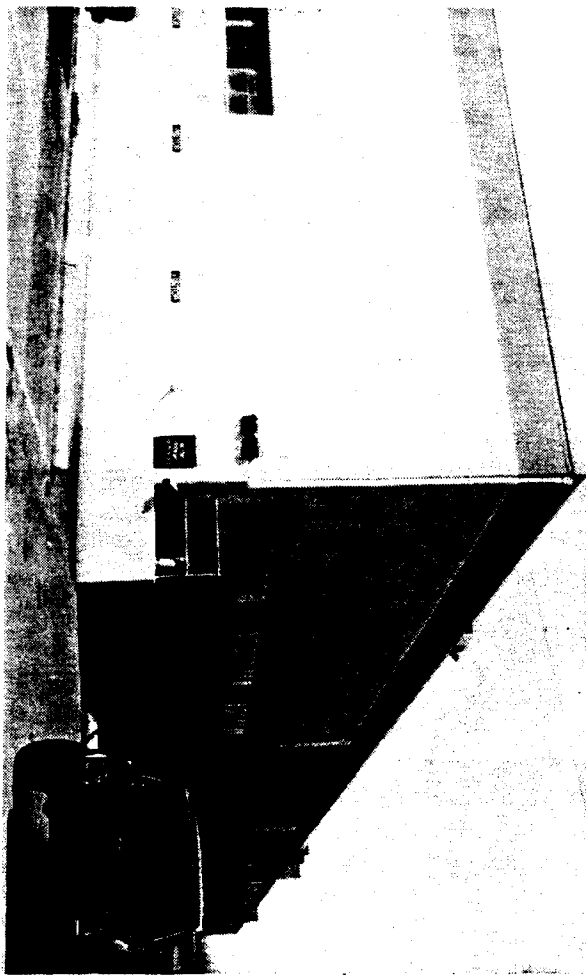
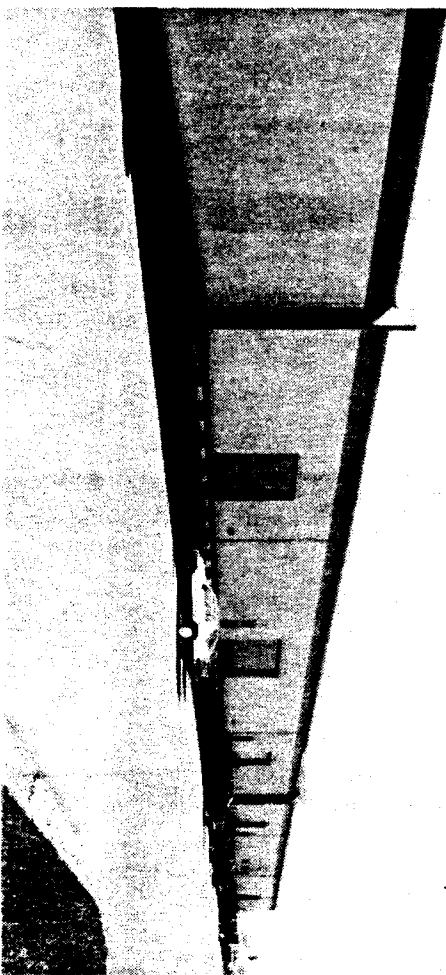
CONCERNS

- Building materials and lack of style are incompatible with campus image – particularly the Field Training Facility (Bldg. 975) directly north of this building.
- The type of windows and quantity of overhead doors facing Randolph Avenue contribute to the industrial appearance of this building.
- The expanse of asphalt paving, loading dock, and excessively wide driveway add to the industrial image.

RECOMMENDATIONS

- Replace windows with anodized aluminum windows.
- Construct a canopy with bronze clad fascia at the overhead doors and paint the doors the same as the wall color.
- Decrease width of entrance drive.
- Construct low wall at street edge of parking lot with split face CMU with landscape berm to match Bldg. 975.
- Add street trees along Randolph Avenue to unify campus boundary and to reduce visibility of this building.
- Add campus style lighting fixtures to reduce industrial image.

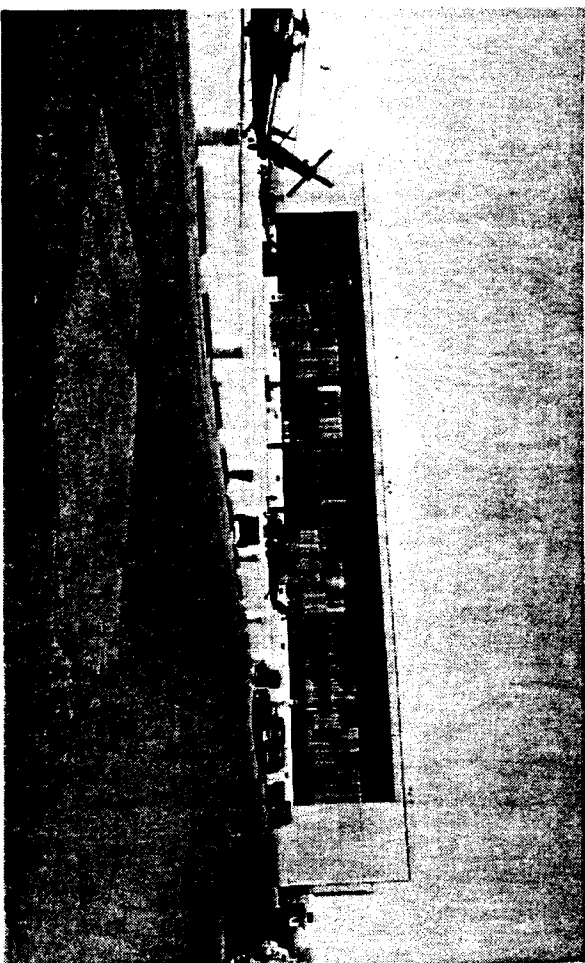
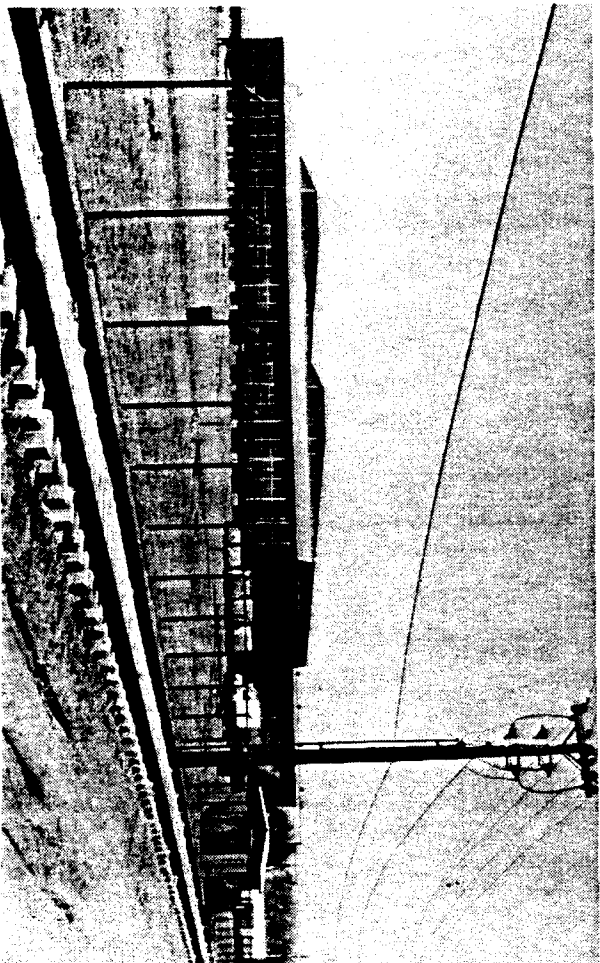
These three hangars are situated on the edge of the flight line adjacent to Parking Apron E. The buildings convey an unmaintained, unattractive image when viewed from the surrounding areas of the base. This unmaintained image results partly because the buildings are clad with asbestos siding.

CONCERNS

- *Building walls are a dirty grey color and present an unmaintained image.*
- *Hangar doors, composed of glass and galvanized sheet metal, are not maintained.*

RECOMMENDATIONS

- *Paint building walls that are not asbestos-clad.*
- *Clad over asbestos containing material with EIFS or remove asbestos and re-clad with corrugated galvanized iron siding to match adjacent hangars and paint.*
- *Paint window frames and metal siding in the hangar doors a darker contrasting color to siding.*
